## PIC18F66K80 Family Silicon Errata and Data Sheet Clarification

The PIC18F66K80 family devices that you have received conform functionally to the current Device Data Sheet (DS39977F), except for the anomalies described in this document.

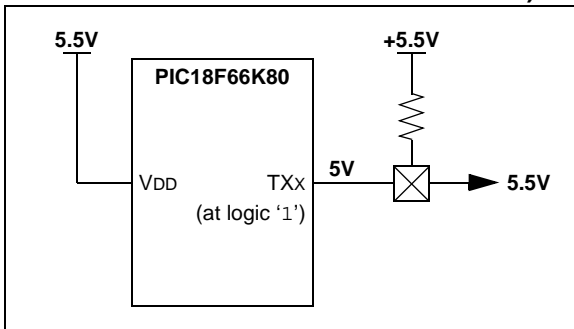
**FIGURE 11-2: USING THE OPEN-DRAIN OUTPUT (USARTx SHOWN AS EXAMPLE)**

[Figure 11-2: Using the Open-Drain Output \(Usart Shown as Example\)](#) on page 173 should be as follows:

**When the open-drain option is required, the output pin must also be tied through an external pull-up resistor provided by the user.**
