**CUI INC**
**Part No: CEP-2272A**
**Description: piezo audio indicator**
**Date: 10/2010**
**Unit: mm**
**Page No: 1 of 4**

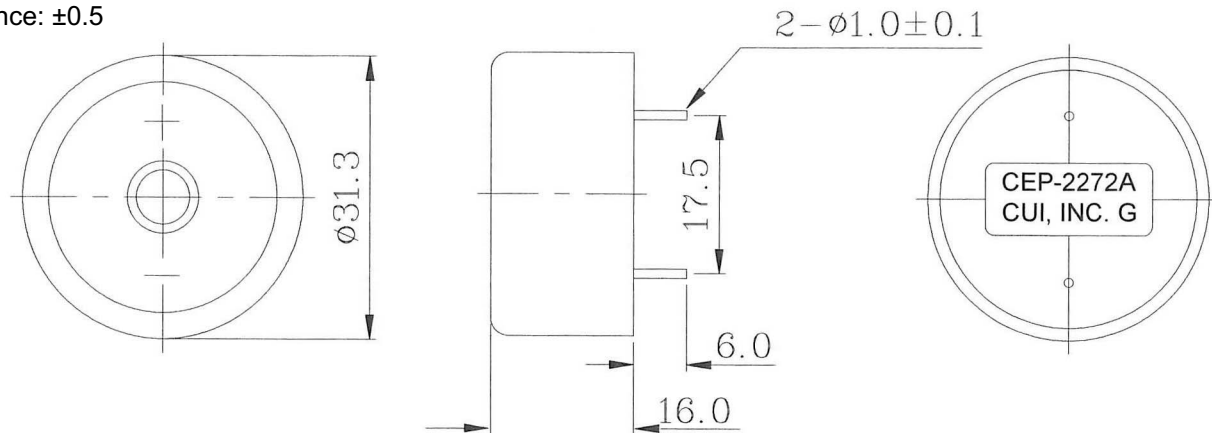
## Appearance Drawing

Tolerance: ±0.5

| Dimensions | ø31.3 x H16.0 mm | See attached drawing |
| Terminal | Pin type (Sn Plating) | See attached drawing |

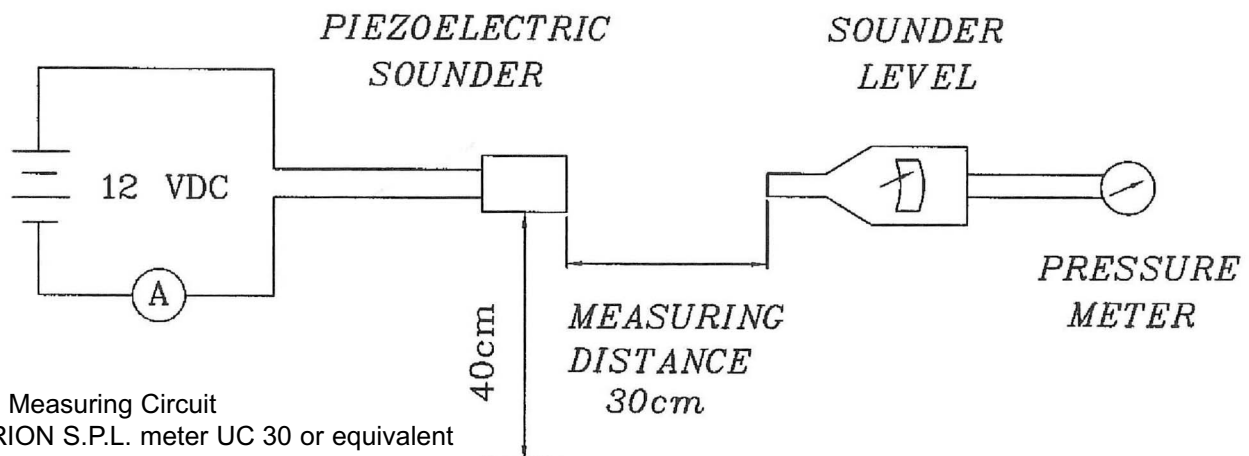
## Measurement Method

| Sound pressure level | 93 db min. | at 30 cm / 12 V dc |

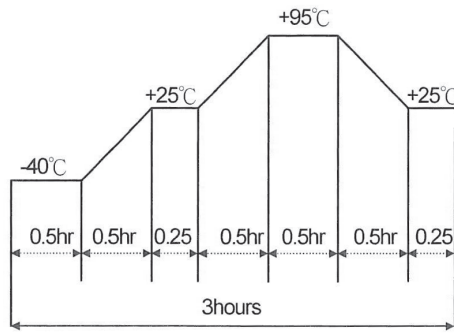
| Item | Test Condition | Evaluation Standard |
|---|---|---|
| Temp. cycle test | The part shall be subjected to 5 cycles. One cycle will consist of:<br> | |

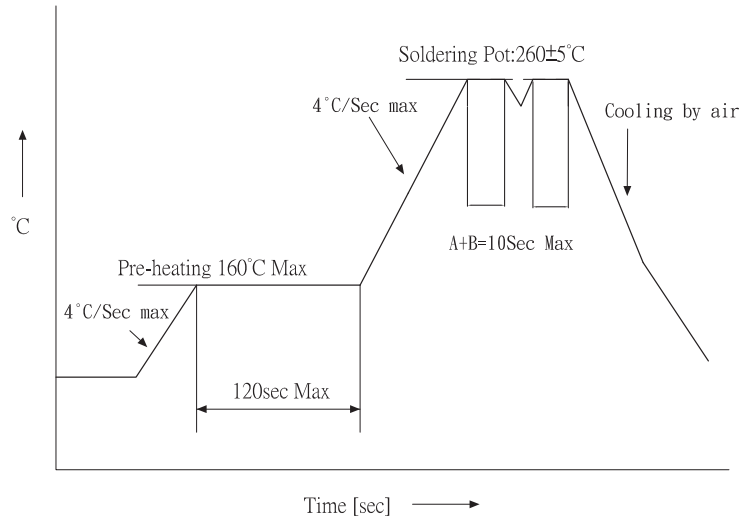
## Wave Solder Profile

Notes: 1. Not recommended for wave soldering

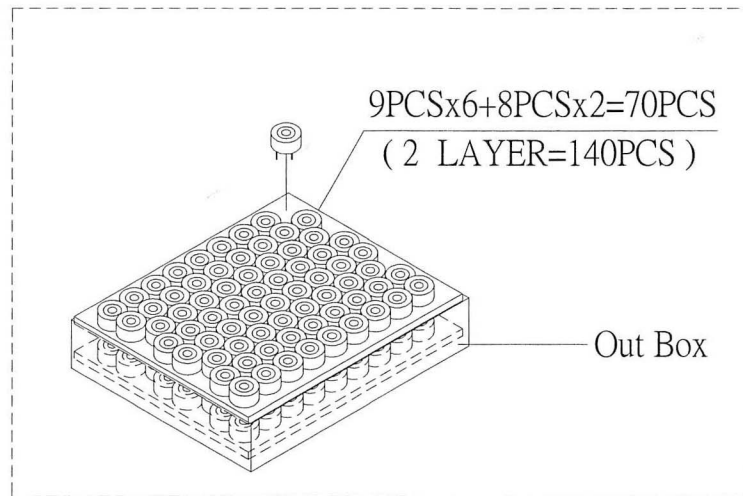
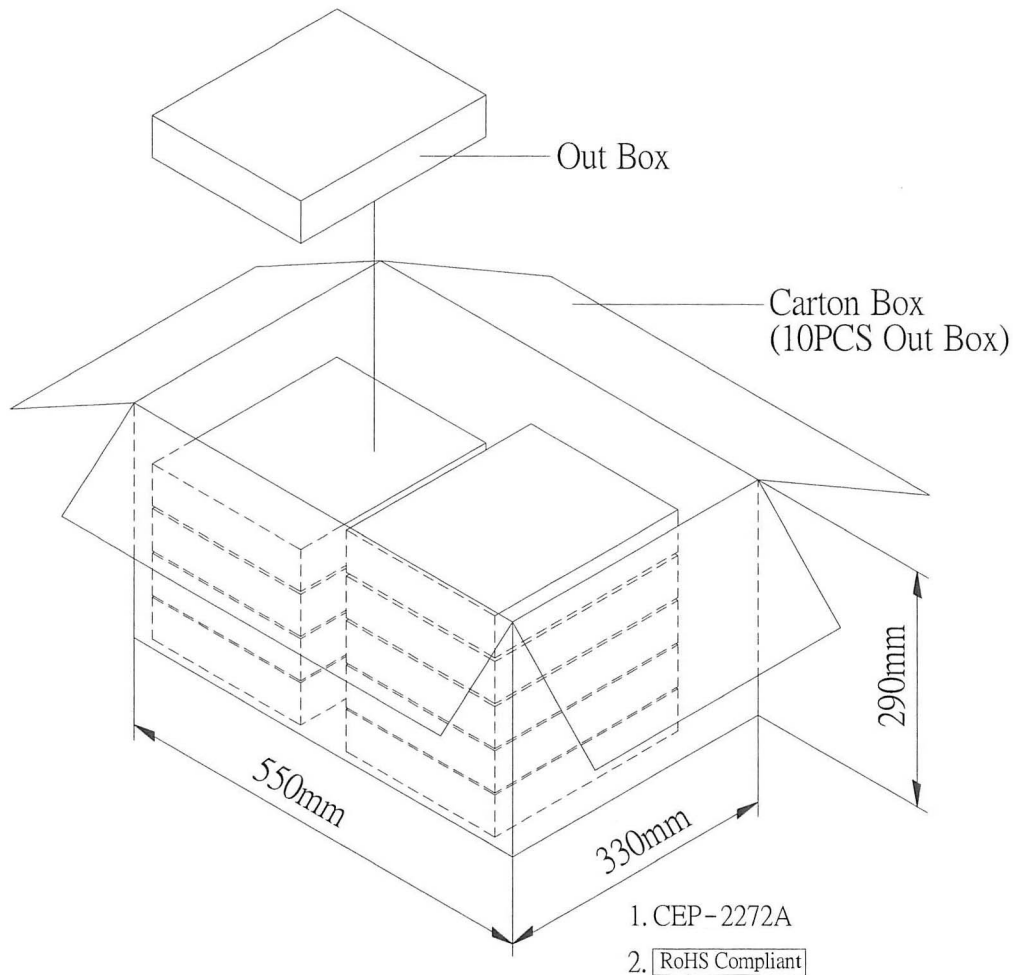
## Packaging

| Out Box | 310mmx248mmx49mm | 1x140PCS=140PCS |
| Carton Box | 550mmx330mmx290mm | 140PCSx10=1,400PCS |
